Report

IN-039/2018

Incident involving two Boeing 737-800 aircraft, registrations EI-FRY and EI-DWW, operated by Ryanair, at reporting point GOSVI at FL340 (Navarre) on 2 October 2018

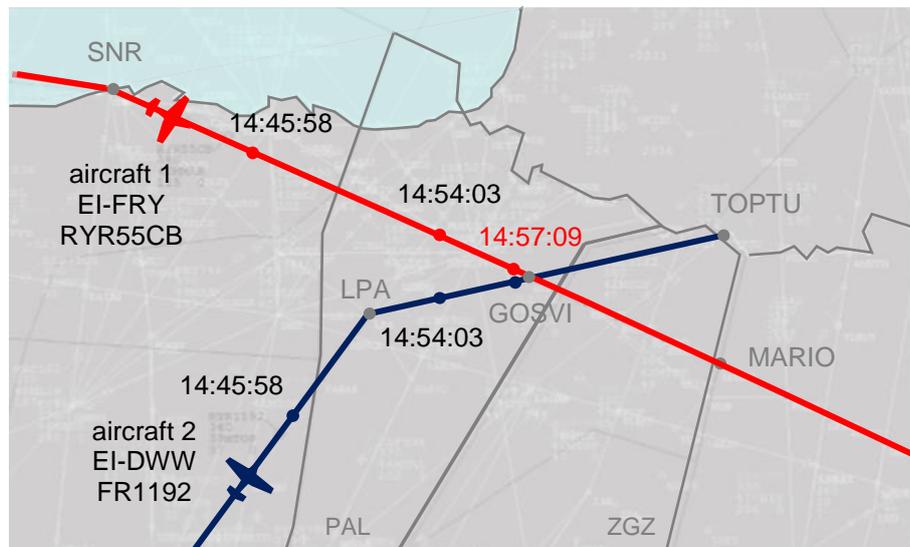
Figure 1. Aircraft flight paths

At 14:45:58, both aircraft were in contact with sector PAL in the Madrid ACC, both at FL340. At 14:54:03, aircraft 2 was transferred to adjacent sector ZGZ in the Madrid ACC, while aircraft 1 remained in sector PAL. Both continued at FL340 on convergent headings toward GOSVI, reducing their separation until they reached the closest point of approach three minutes later, at 14:57:09.

The event took place in the vicinity of point GOSVI. At their closest point, the aircraft were 2.3 NM apart horizontally and 334 ft apart vertically, with aircraft 1 above aircraft 2.

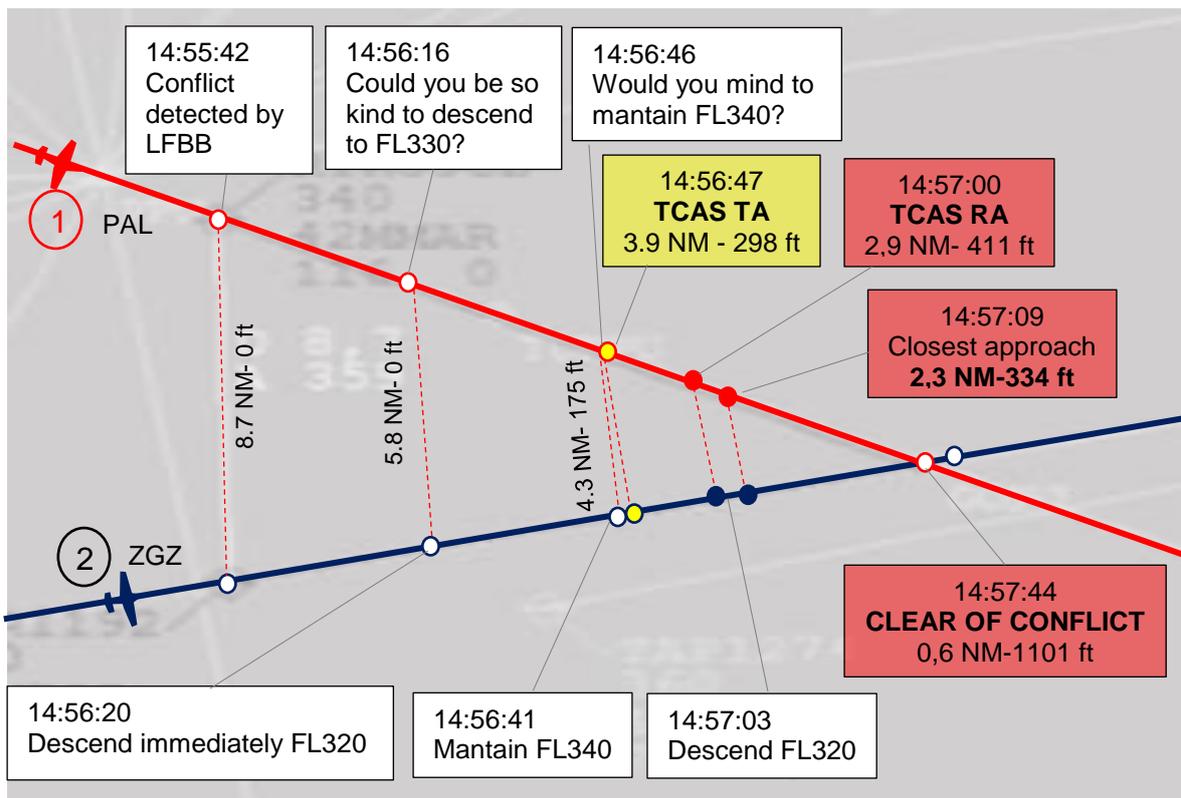
Figure 2. Flight paths between 14:55:42 and 14:57:44

At 14:54:36, an STCA PAC alert should have appeared for the two aircraft. This alert, which is displayed about 2 min before the minimum required separation is breached, was not generated².

14:55:42 The Bordeaux ACC controller notified the PAL sector controller of the conflict between the two aircraft. Judging by his reply, the PAL controller had not detected it. At this time, the aircraft were still level at FL340 and 8.7 NM away. Immediately

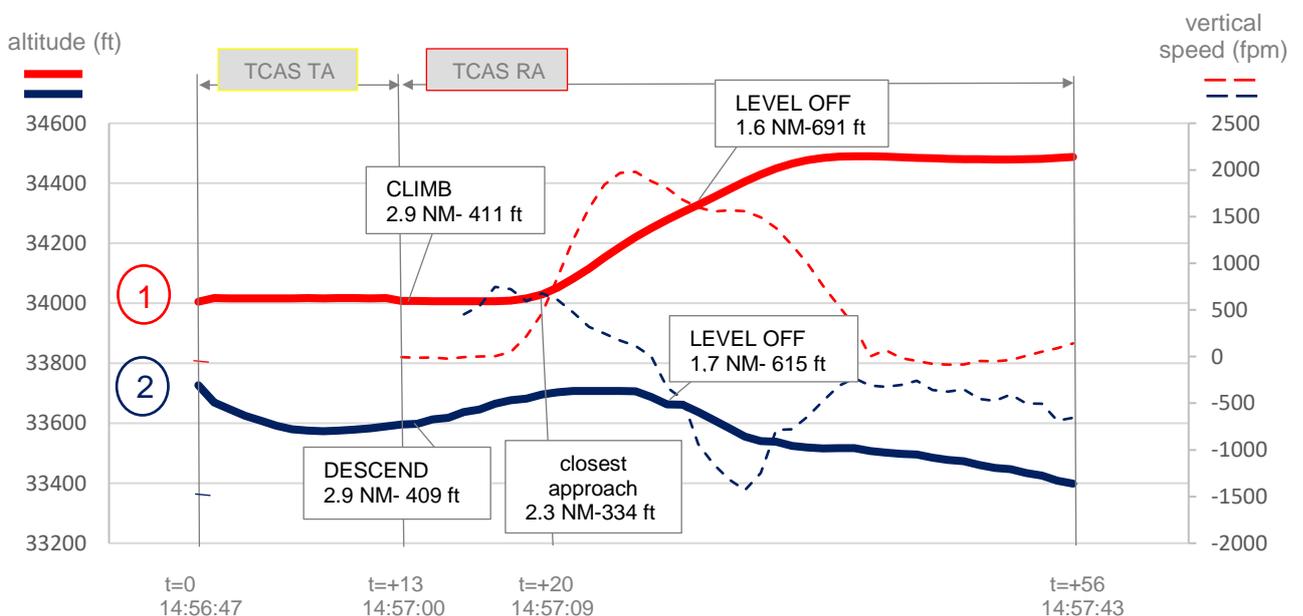
Figure 3. Changes in altitude and vertical speed during the TCAS RA

- 14:57:00-18 TCAS “CLIMB” RA in aircraft 1, which was level at FL340. This advisory was in effect for 18 seconds, during which:
- 14:57:02: the A/P and A/T were disengaged.
 - 14:57:09: the aircraft reached the point of closest approach, 2.3 NM and 334 ft (aircraft 1 at 34029 ft and aircraft 2 at 33695 ft).
 - 14:57:16: the aircraft reported TCAS RA to ATC.
 - The vertical speed began to increase gradually to a maximum of +1979 fpm.
 - The aircraft climbed a total of 328 ft.
- 14:57:01-16 TCAS “DESCEND” RA in aircraft 2, which was climbing at a rate of +544 fpm. This advisory was in effect for 15 seconds, during which:

- The vertical speed decreased gradually from the initial values, which were in excess of +500 fpm, to around 0 fpm.
- Due to these positive values for vertical speed, the aircraft initially climbed toward aircraft 1, resulting in the closest point of approach at 14:57:09, after which aircraft 2 began to descend while aircraft 1 accelerated its climb, increasing the vertical separation between them.

- This phase lasted 16 s, during which aircraft 2 had a net elevation gain of 89 ft.

- 14:57:17-43 TCAS “LEVEL OFF” RA in aircraft 2, with a descent rate of -330 fpm. At that time, the separation between the aircraft was 1.7 NM and 615 ft. This advisory was in effect for 26 s, during which:
- The vertical speed continued to increase for 5 s, reaching a maximum rate of -1431 fpm. It then decreased to -259 fpm as the aircraft leveled off.
 - The aircraft descended a total of 264 ft during this period.
- 14:57:19-43 TCAS “LEVEL OFF” RA in aircraft 1, with a climb rate of +1597 fpm. At that time, the separation between the aircraft was 1.6 NM and 691 ft. This advisory was in effect for 24 s, during which:
- At 14:57:23, the vertical speed decreased and stabilized at around 0 fpm.
 - The aircraft climbed 159 ft during this period, thus maintaining its altitude.
 - The aircraft was transferred by the PAL controller to ZGZ, to whom it again reported the TCAS RA at 14:57:37.
